# Airport Power System Protected From Systemic Installation Defects

IMCORP Enables Utility to Fix Components and Upgrade Installation Instructions

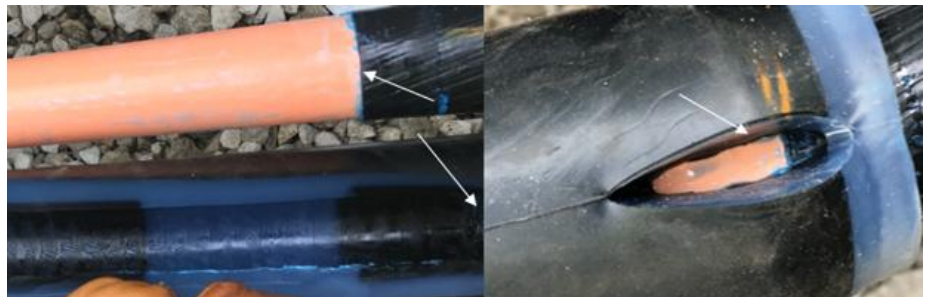
The dissections and root cause analysis identified insufficient void filling compound, and joint body damage. These issues caused void and stress enhancements inside the joint. Voids and stress enhancements in the presence of sufficient voltage stress gives rise to partial discharge, erosion, electrical treeing and eventually failure.

The utility and manufacturer's instructions explained to "lubricate the cable insulation up to the semi-con cutback". The word lubricate likely mislead the installers into thinking a thin coat of void filler would be sufficient when actually a thick bead is needed to fill the semicon cutback step and eliminate interfacial voids.

Fig 1&2 Insufficient blue void filler observed at the critically important semicon cutback
