# **Commissioning Cable System for Key Account Customer**

Danielle Anderson – APS UG Engineer

# Splice Root Cause Analysis - Summary

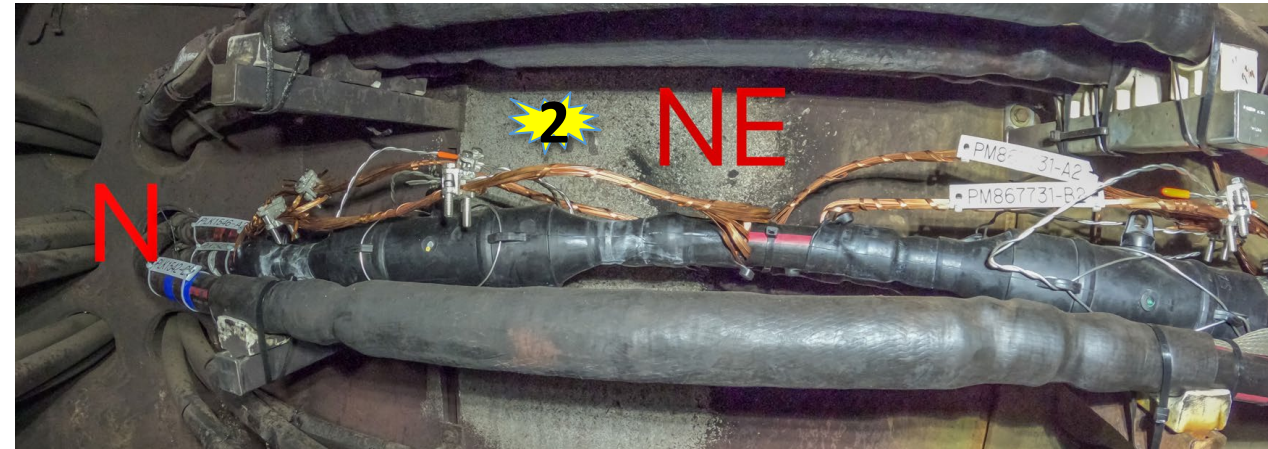
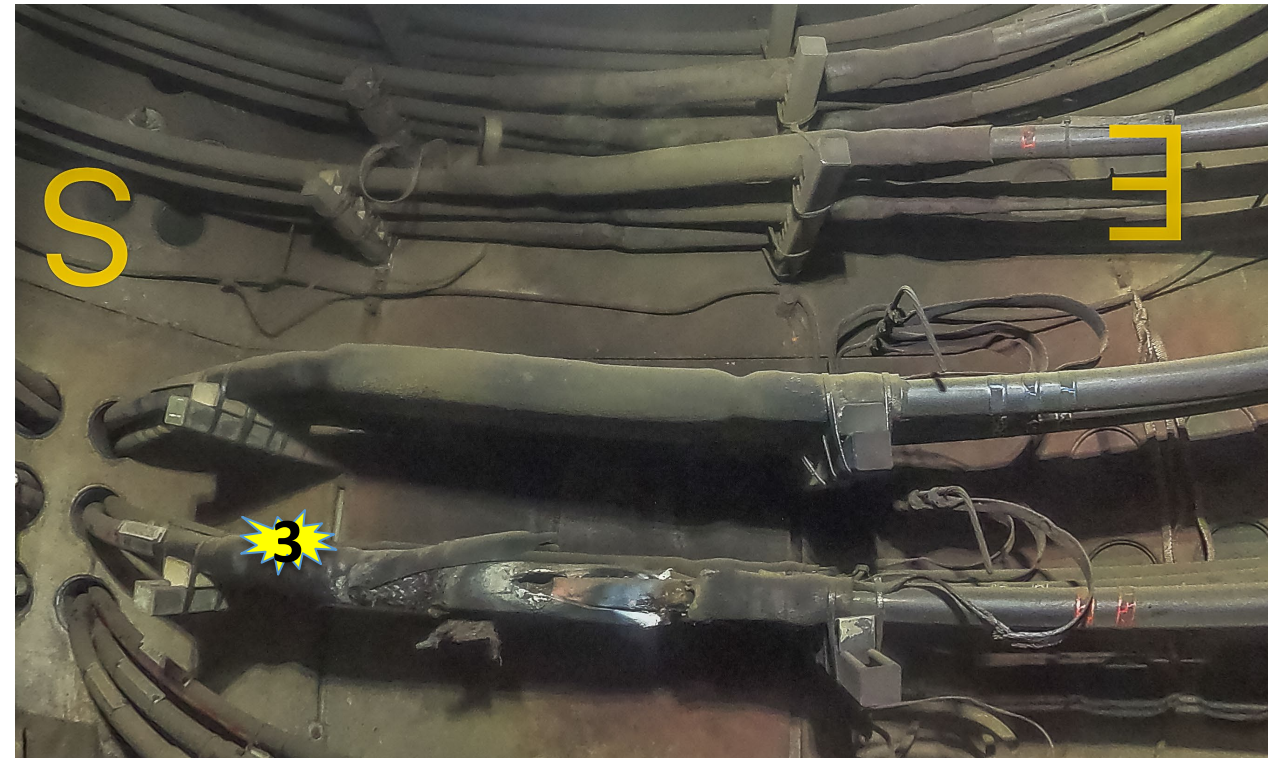
- Multiple feeders in manhole
- For safety reasons, all feeders in manholes were de-energized to make splice repairs causing major impacts to our customer

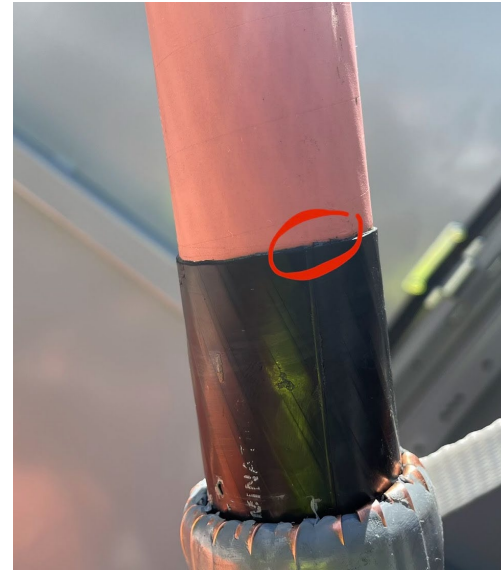
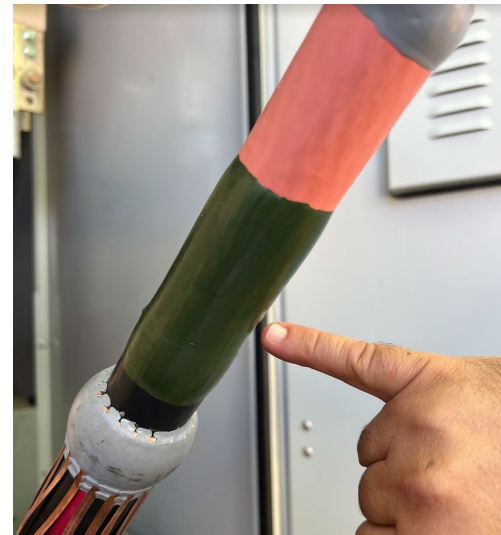
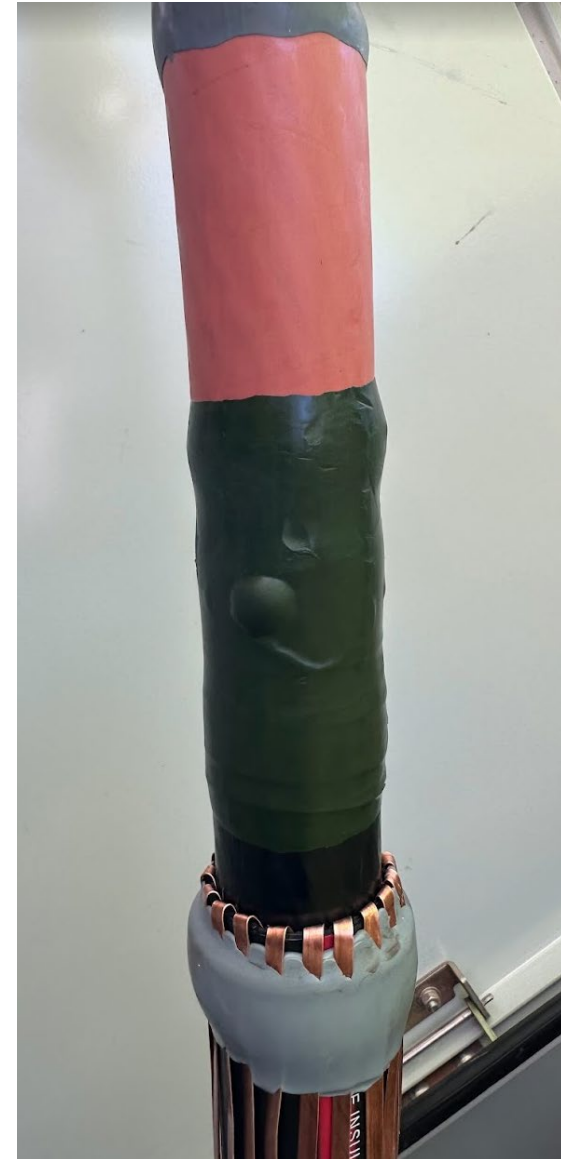
- Installation crews were required to rebuild multiple terminations due to PD detection found at 1.0 U<sub>o</sub> and 1.5 U<sub>o</sub>
- PD Testing found some subpar termination installs
- PD Testing forced installation crews to slow down and be super meticulous at critical steps during installs

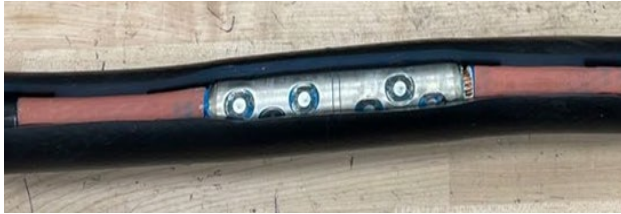
Sample ID	Observations
Joint Sample 1	<ul style="list-style-type: none"> <li>• Root cause of faulted joint was determined to be a dimensional error. The dimensions used to make the semi-con cutbacks were too long, causing the overall cable dimension within the splice body to be too long. This caused the stress control within the splice body to be misaligned over the cable.</li> </ul>
Joint Sample 2	<ul style="list-style-type: none"> <li>• Both semi-con cutbacks were not radial. Discharge control compound (Blue Grease) was scarce along cable insulation.</li> <li>• Splice body was not centered over entire joint.</li> </ul>
Joint Sample 3	<ul style="list-style-type: none"> <li>• Right side semi-con cutback was not radial.</li> </ul>
Joint Sample 4	<ul style="list-style-type: none"> <li>• Both semi-con cutbacks were not radial. The dimensions used to make the semi-con cutbacks were too long, causing the overall cable dimension within the splice body to be too long.</li> <li>• Splice body was not centered over entire joint. This, combined with dimensional error, caused the stress control within the splice body to be misaligned over the cable.</li> </ul>

DIMENSION CUTBACK TO CUTBACK = 20 ½"  
SPECIFICATION - NOT BE GREATER THAN 19 ¾"

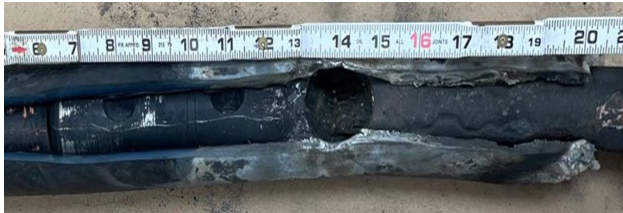
DIMENSION CUTBACK TO CUTBACK = 20 ½"  
SPECIFICATION - NOT BE GREATER THAN 19 ¾"

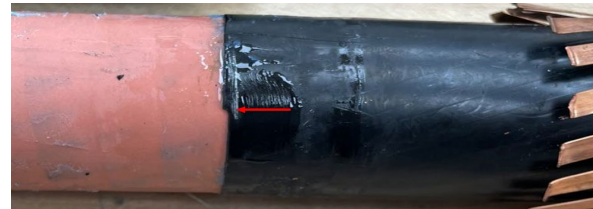
SEMI-CON CUTBACK IS NON-RADIAL

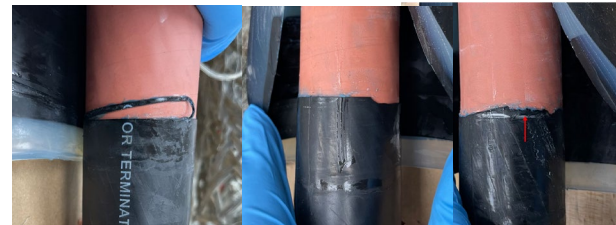
IMPROPER CUTBACKS

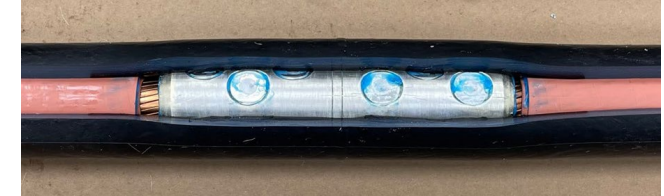
BLUE DISCHARGE CONTROL COMPOUND (DCC)  
SCARCE ALONG INSULATION

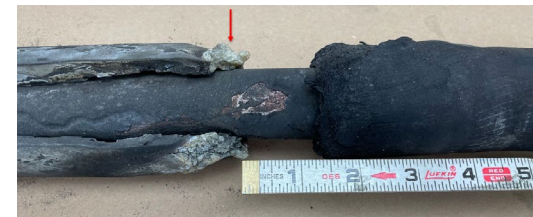
SPLICE BODY NOT OVERLAPPING SEMI-CON

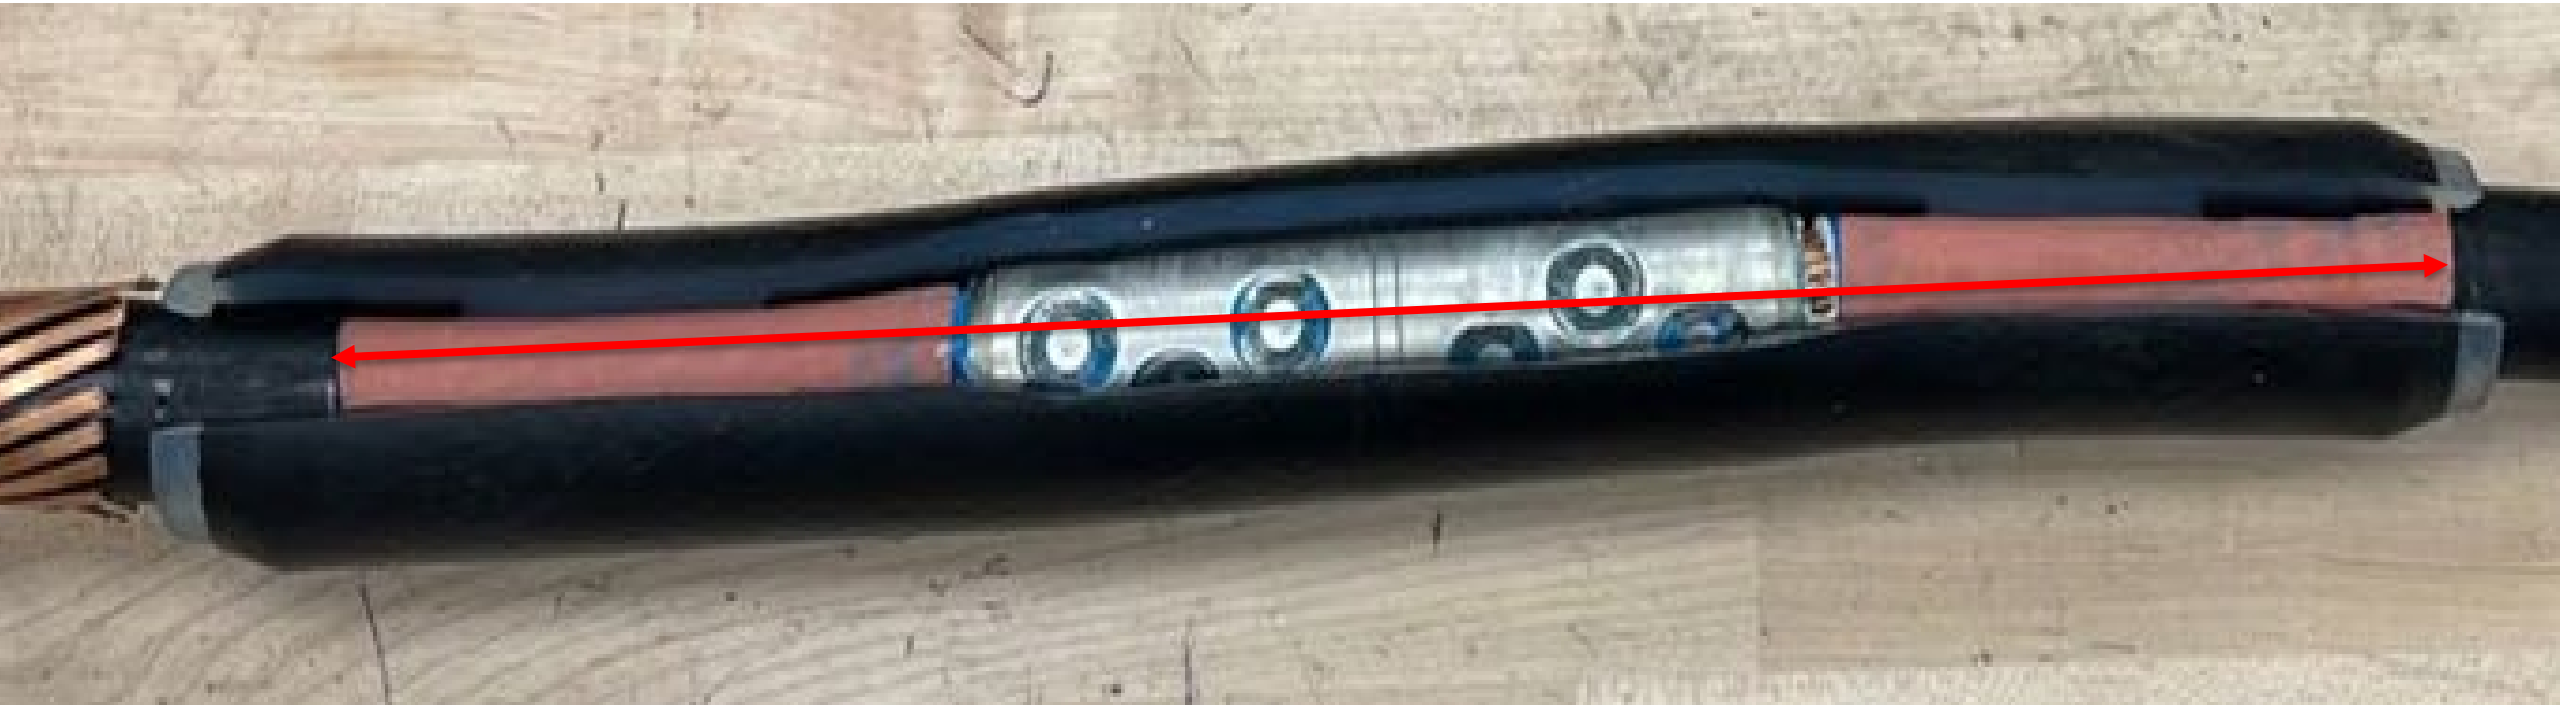
**DIMENSION CUTBACK TO CUTBACK = 20 ½"**

**SPECIFICATION: NOT BE GREATER THAN 19 ¾"**

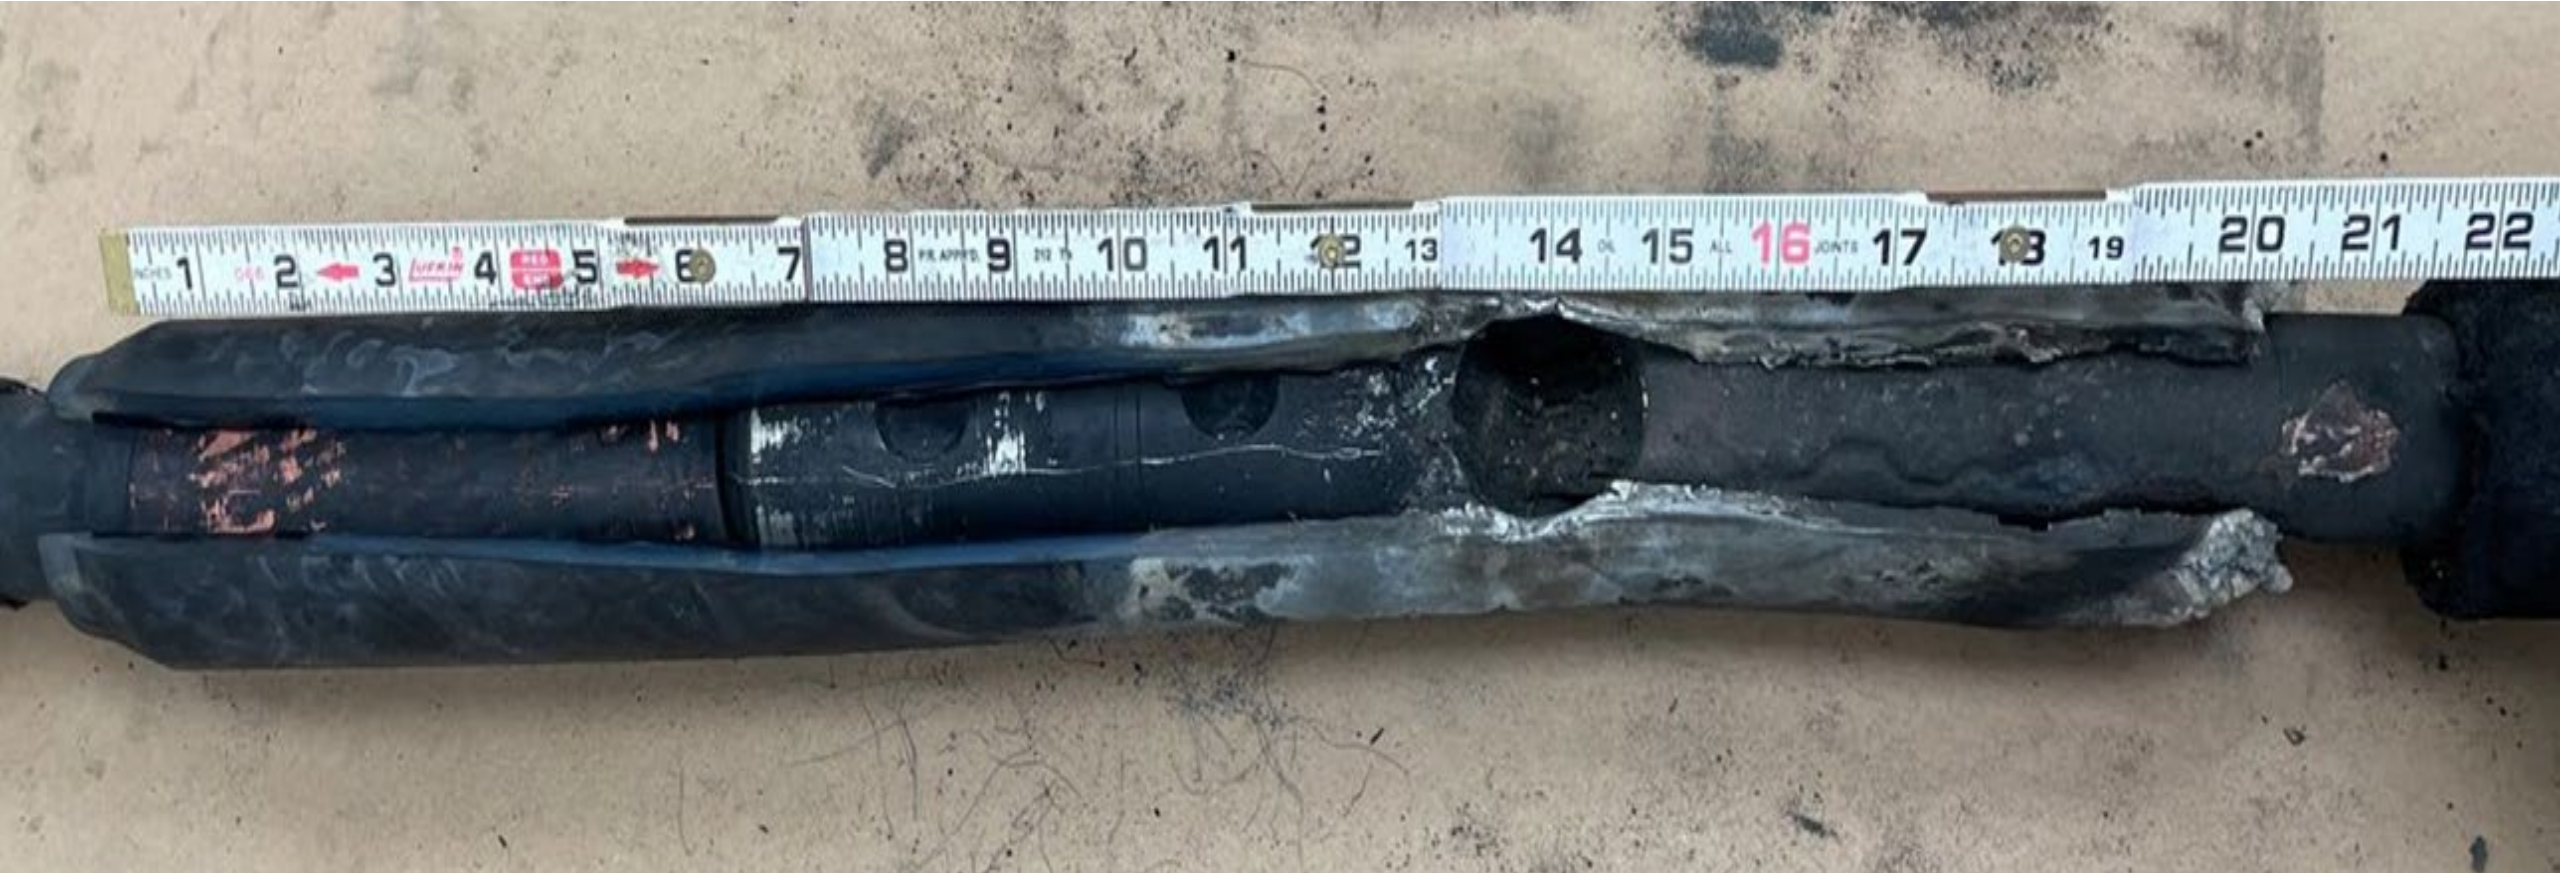
**DIMENSION CUTBACK TO CUTBACK = 20 ½"**  
**SPECIFICATION - NOT BE GREATER THAN 19 ¾"**

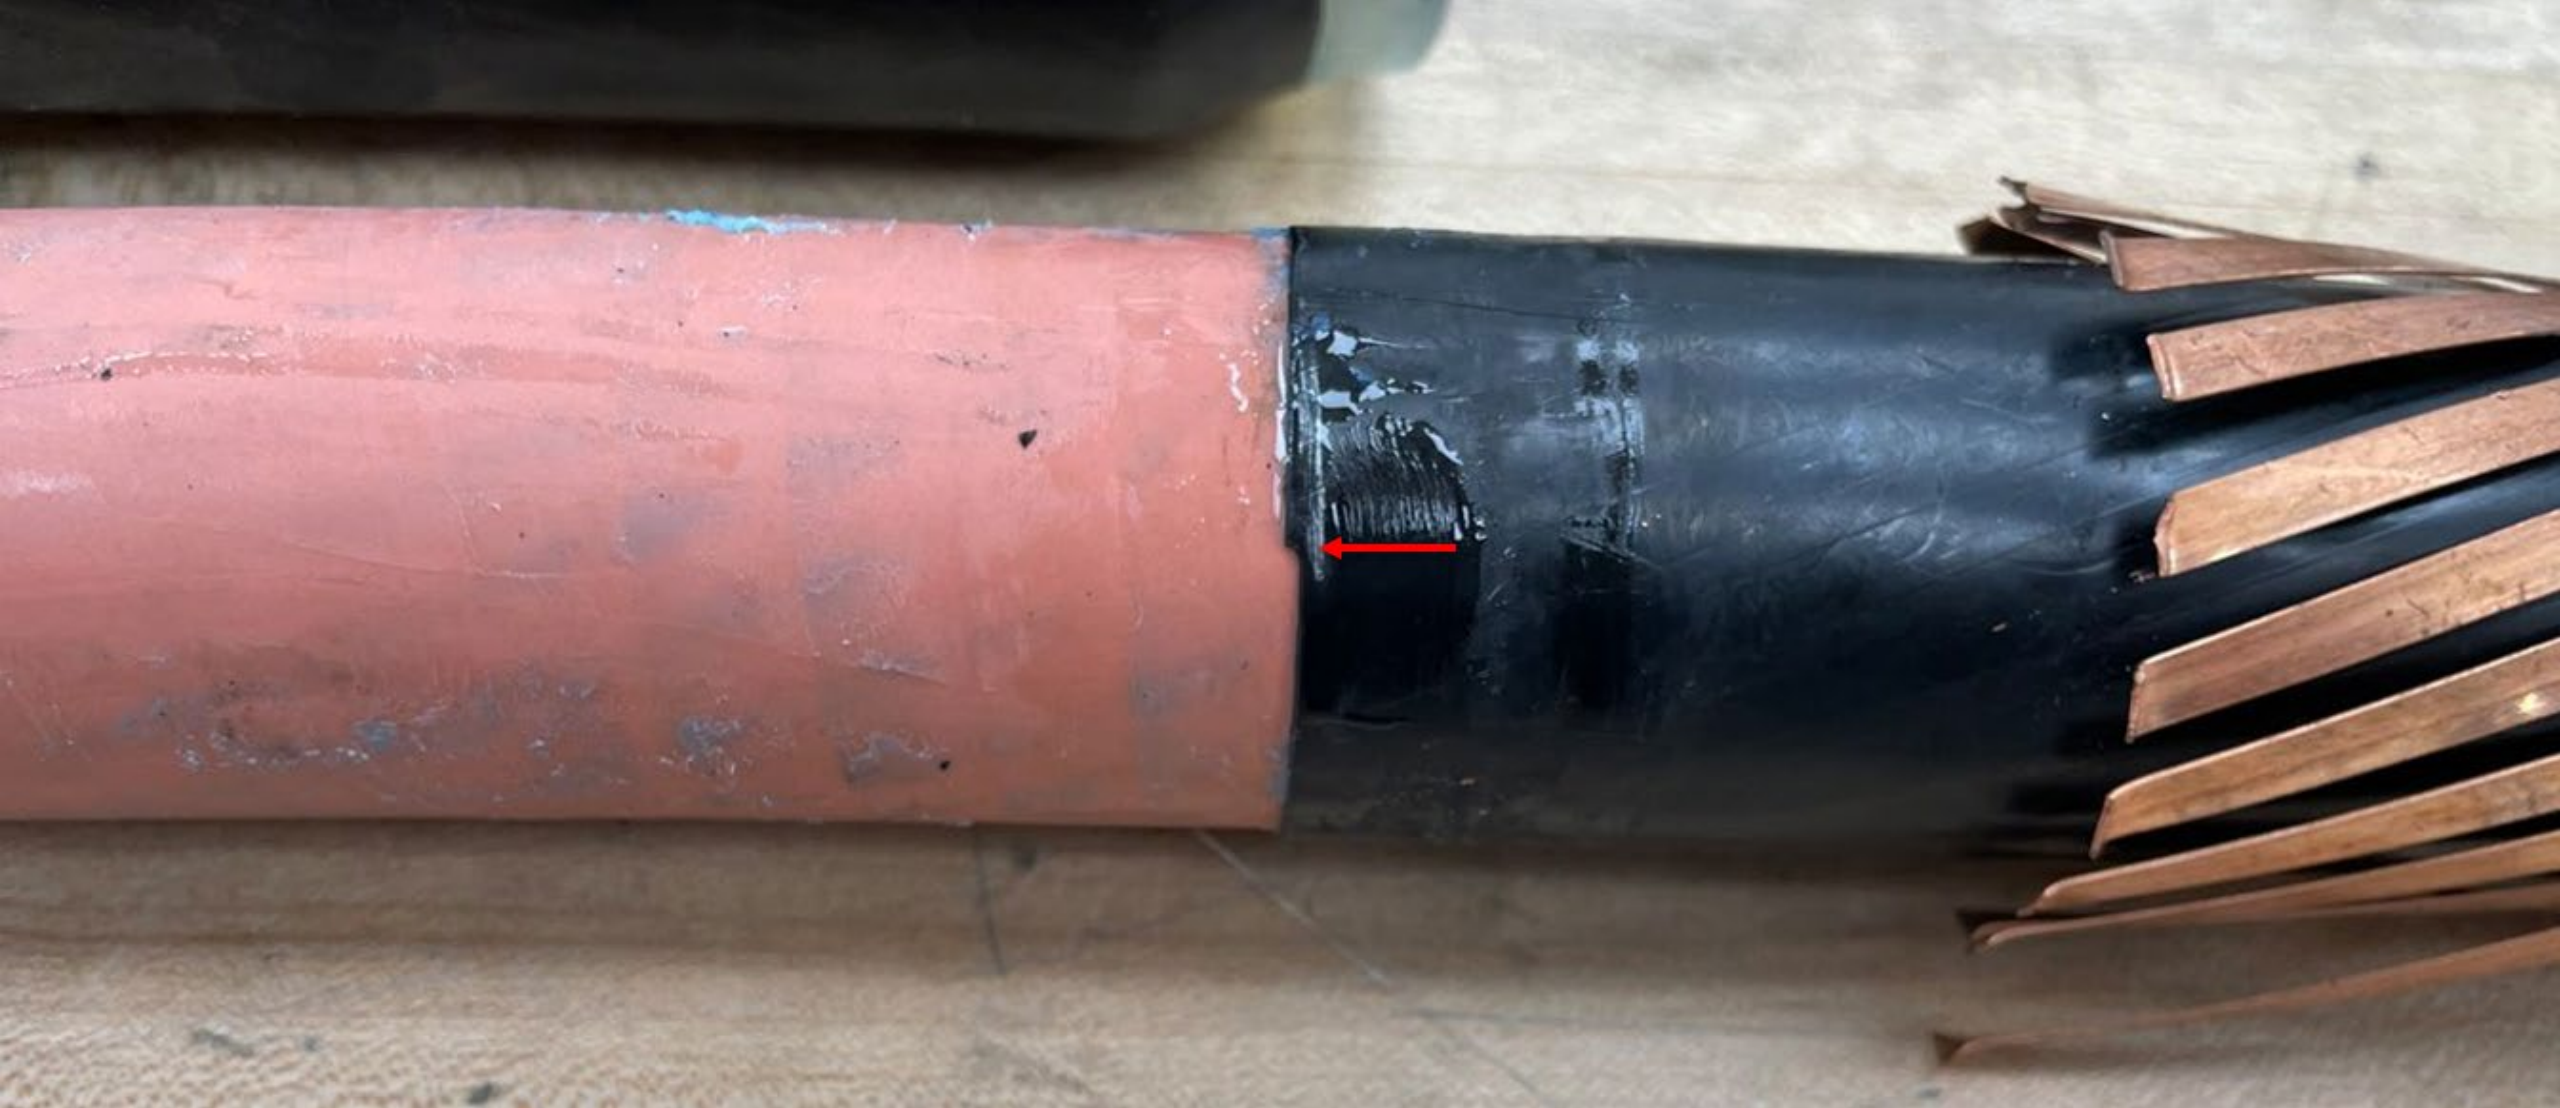
**Right side semi-con cutback is non-radial and would likely exhibit substandard performance.**

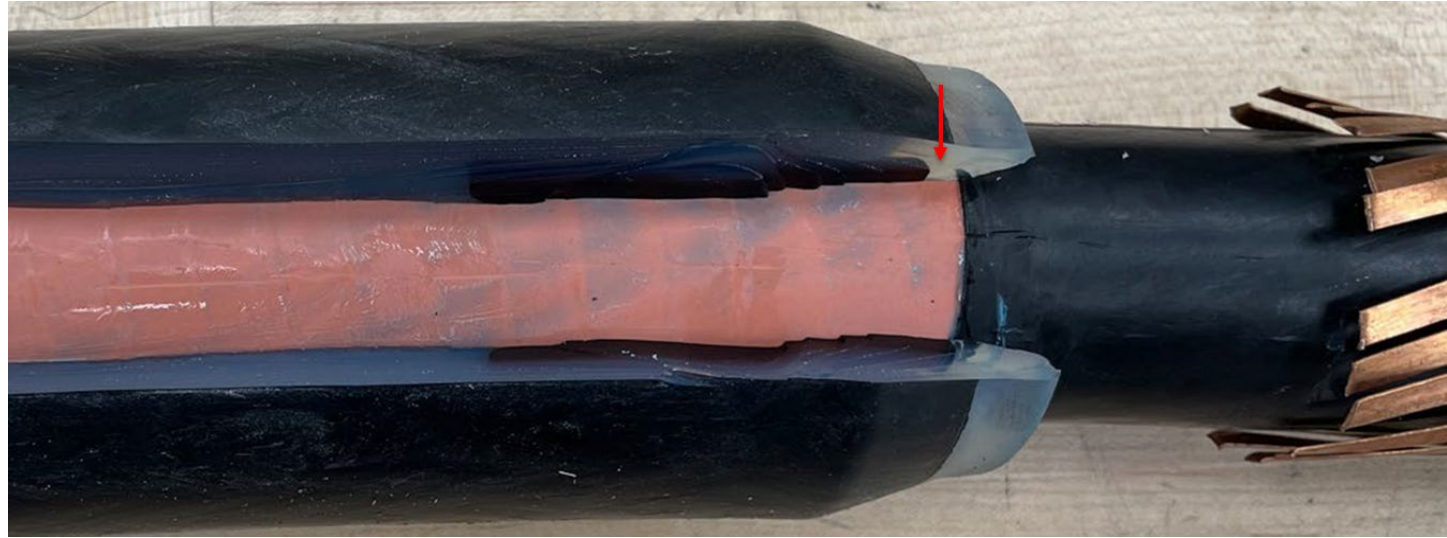
**SPLICE BODY NOT OVERLAPPING SEMI-CON**

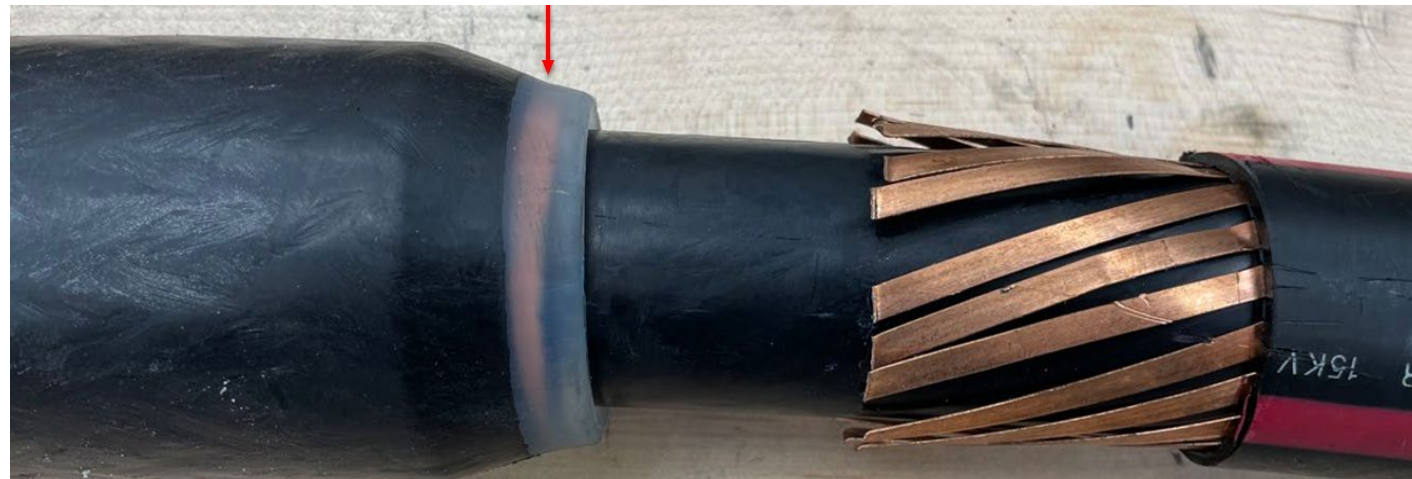
**SPLICE BODY NOT OVERLAPPING SEMI-CON; INSULATION IS VISIBLE**

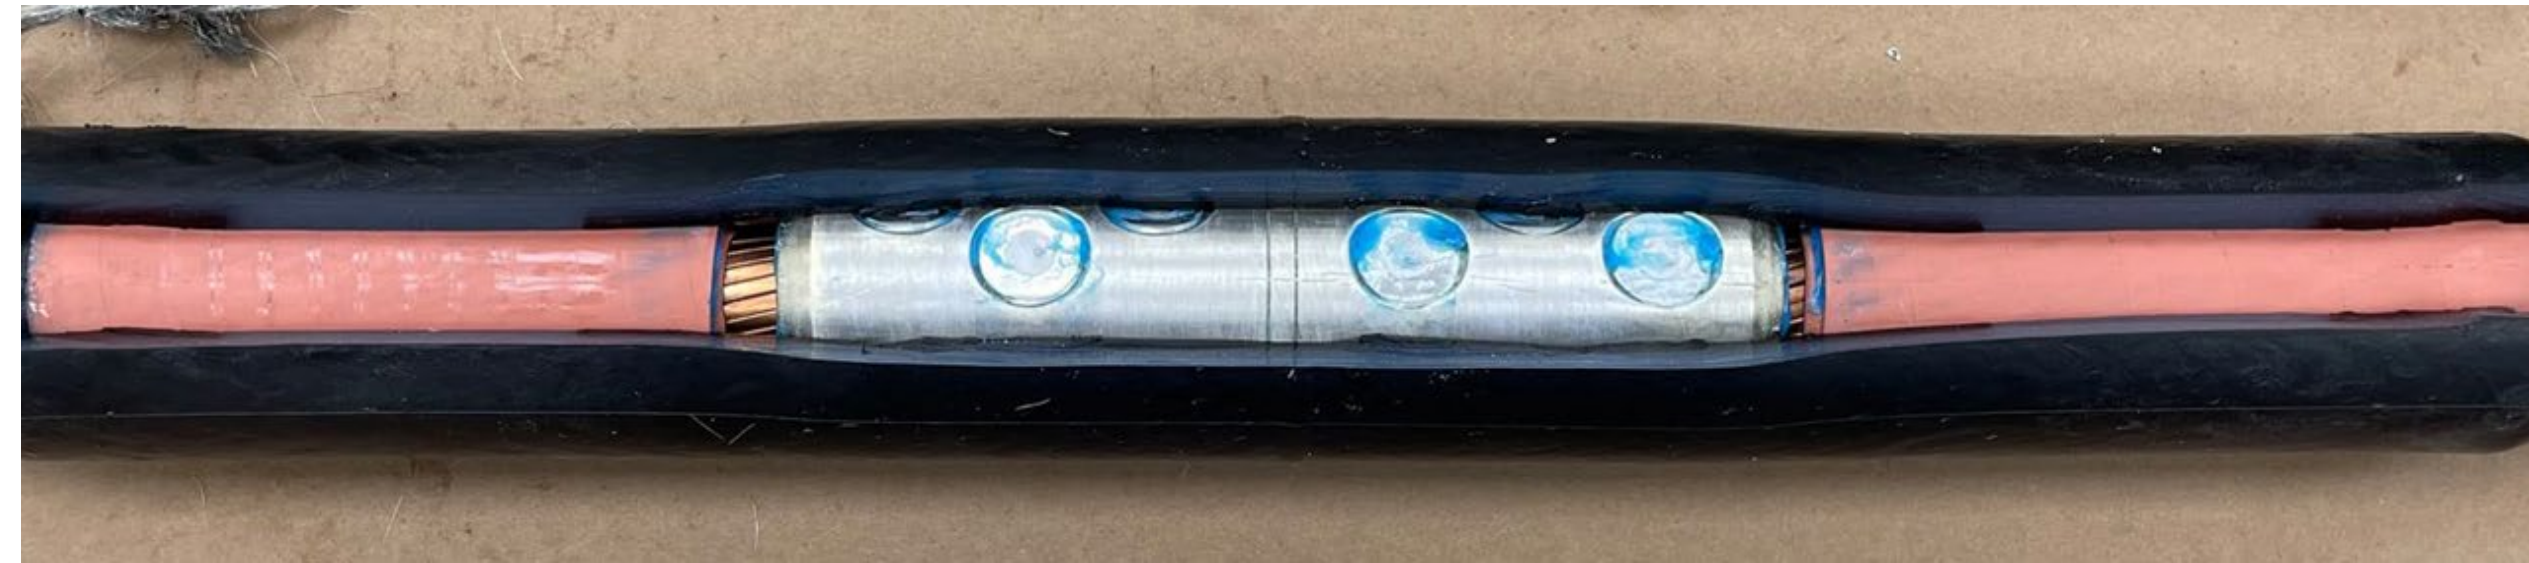
**BLUE DISCHARGE CONTROL COMPOUND (DCC) SCARCE ALONG INSULATION**

**SPECIFICATION: APPLY DCC ABUNDANTLY ALONG INSULATION AND SEMI-CON CUTBACK**

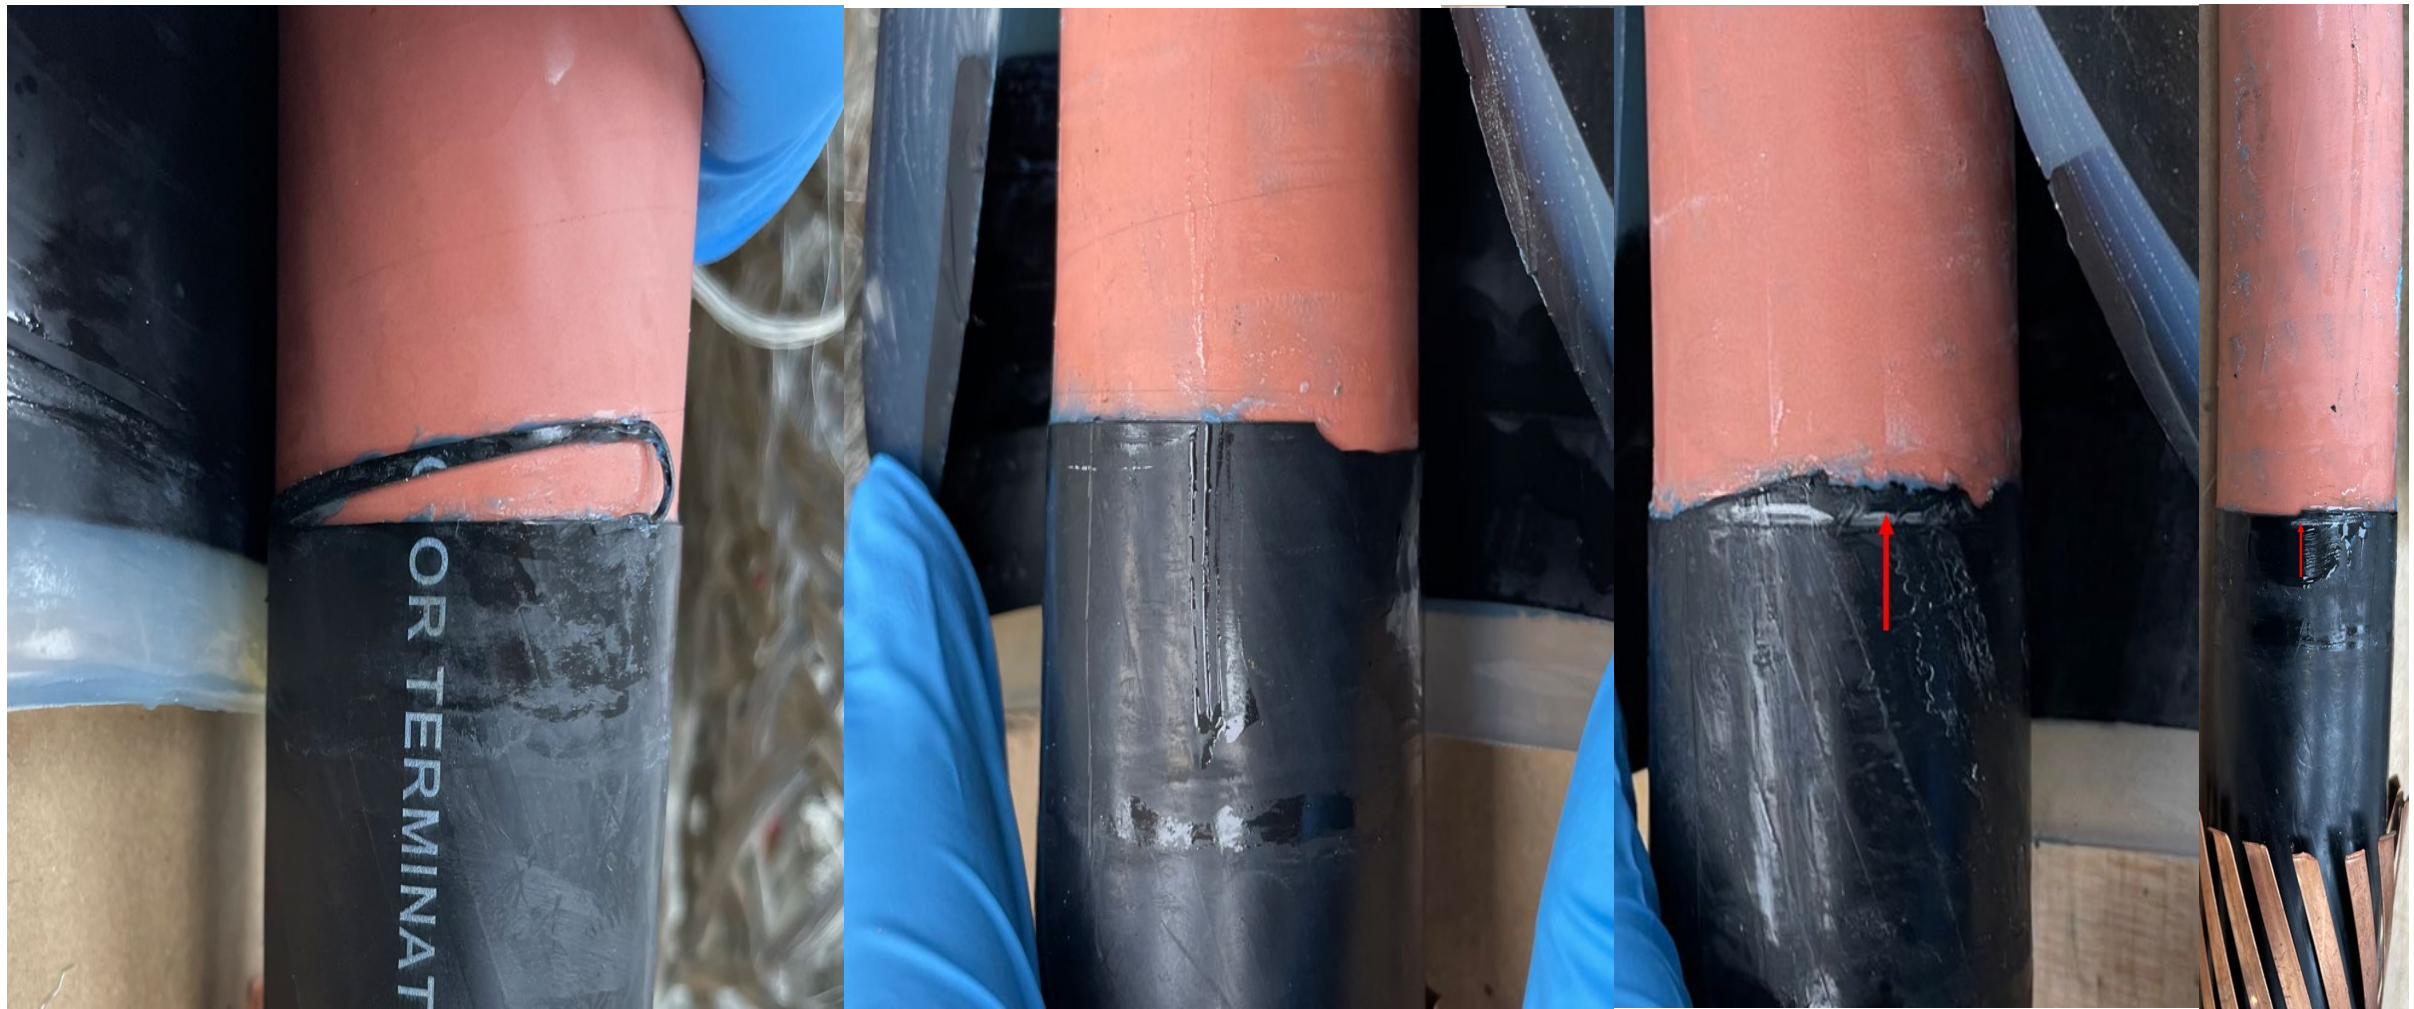
**IMPROPER CUTBACKS**

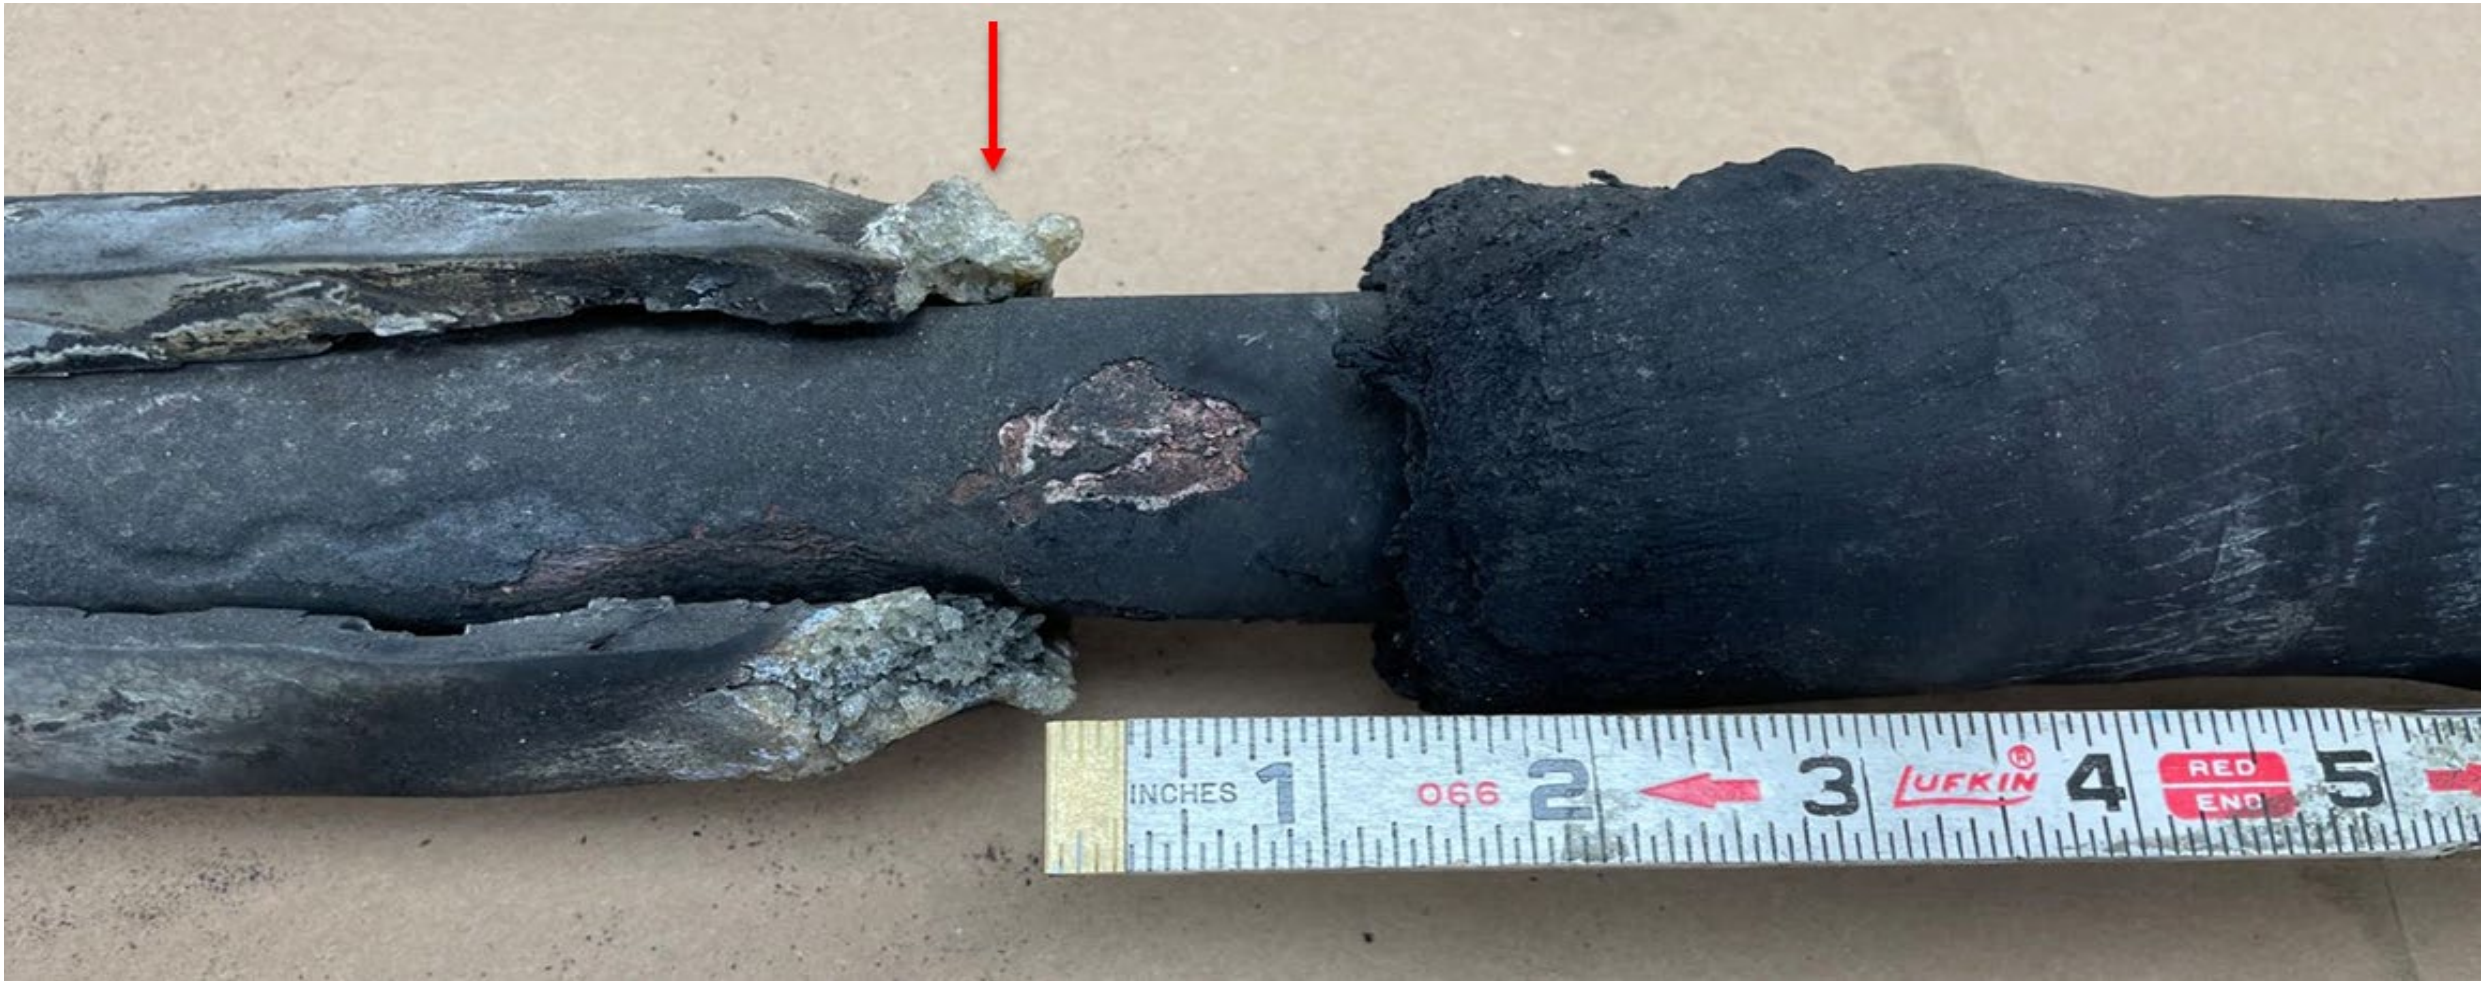
**SPLICE BODY NOT OVERLAPPING SEMI-CON**
