# **Commissioning Cable System for Key Account Customer**

Danielle Anderson – APS UG Engineer

# Splice Root Cause Analysis - Summary

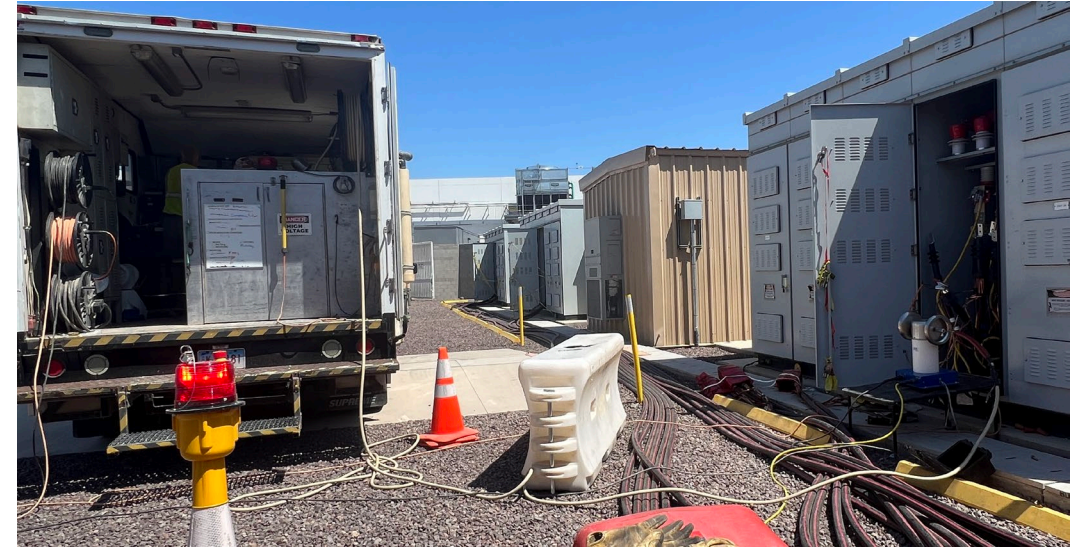
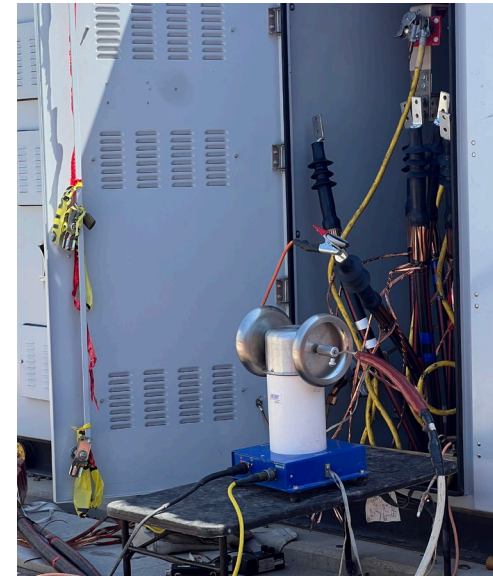
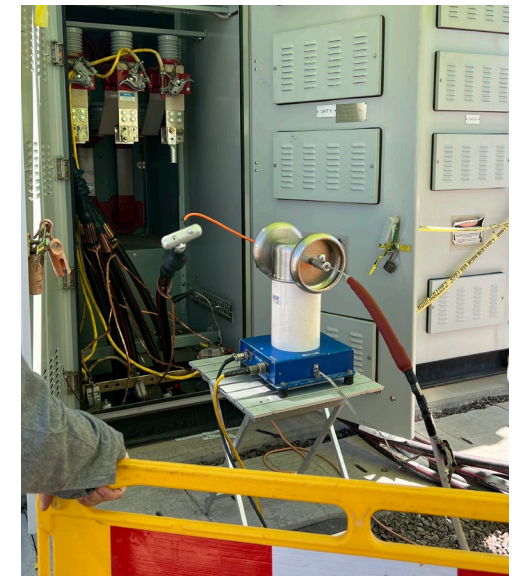
- Sent faulted splices and a select few non-faulted splices out for evaluation
- Performed Partial Discharge (PD) commissioning testing on all newly installed feeders
- PD testing distribution feeders has not been an APS practice
- Performing this additional test showed our commitment to ensure the reliability of all newly installed feeders

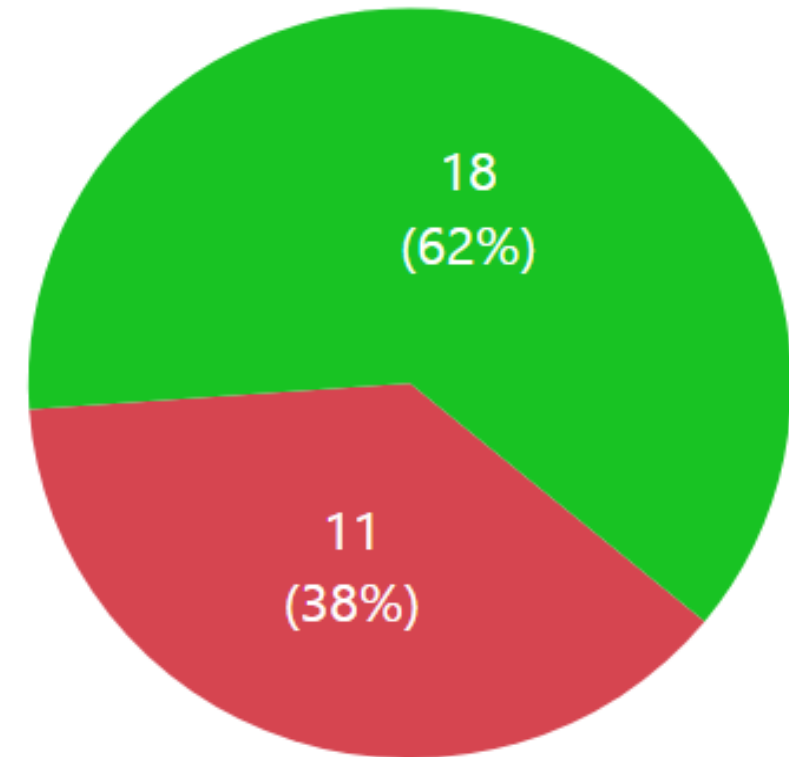
### Pre-Mitigation

11 of 29 [38%] of New Segments Did Not Meet Standard

● Meets Standards ● Substandard

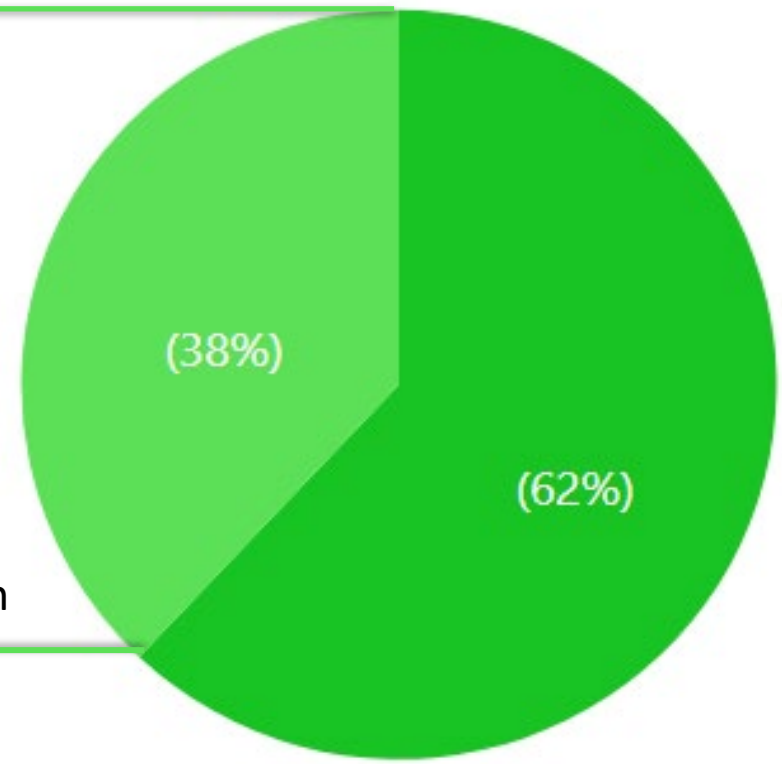
**Post-Mitigation**

● Meets Standards ● Meets Standards Mitigated

## MITIGATION METHODS

- Decontamination
- Corrected Cutback
- Corrected Stress Control Position
- Mechanical Void Compression
- Reapplied Void Filler (Mastic)
- Replaced Termination
