## Underground Facilities

# Managing Cable Assets

CenterPoint Energy uses innovative technology to breathe new life into aging underground loops to boost electric reliability and reduce costs.

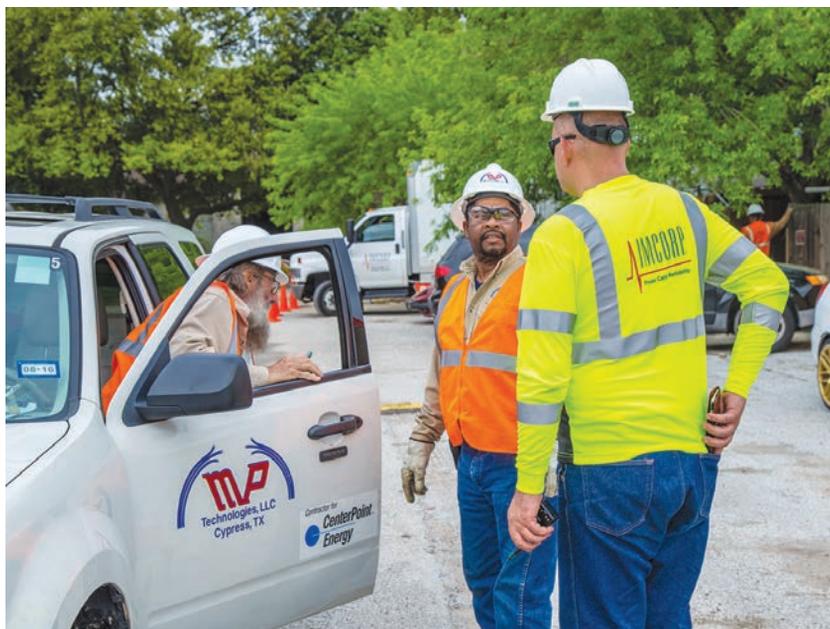
Teams of technicians work together to perform an assessment and complete any on-site mitigations, which includes isolating the cable and connecting the assessment equipment, performing the check and recording the results, and repairing or replacing terminations.

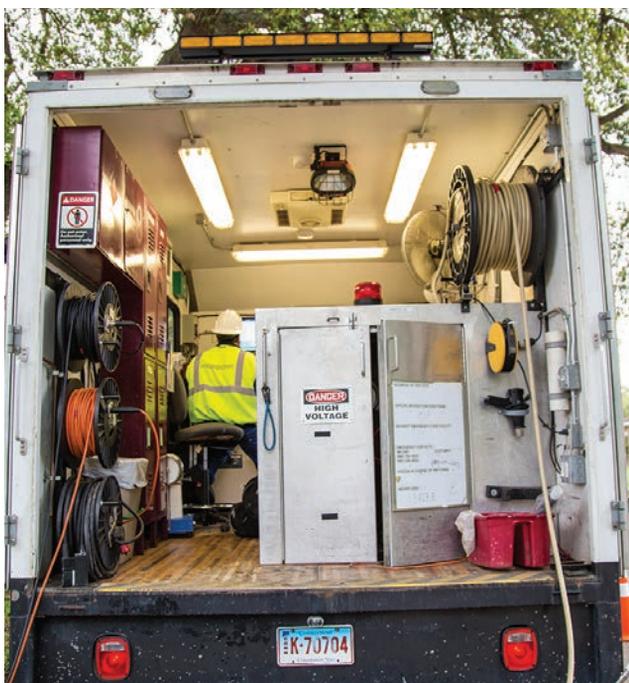
Mobile diagnostic units achieve factory-comparable results when performing assessments in the field. CenterPoint Energy gets maximum value from this form of assessment, because issues that impact installation and operational quality can be identified, pinpointed and corrected.

With factory-grade technology, IMCORP's mobile diagnostic units accompany line skill support crews to assess underground cables and terminations within URD loops proactively. By sending an electric charge through each span in a loop at the standard operating voltage and then two higher voltages, technicians can detect any weaknesses and determine which specific part needs to be replaced, rather than rehabilitating the entire loop. The line skill support trucks are outfitted as rolling warehouses, enabling crews to perform mitigation on-site. Following this process, CNP rejuvenated 511 loops in 2014, compared with 36 loops the previous year, before the new program was implemented. This enables the utility to have broader reach at a fraction of the cost.

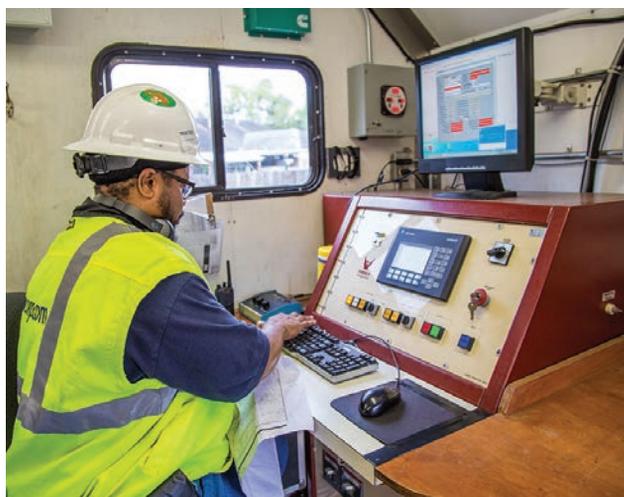
A technician performs and monitors the assessment of the cable. The assessment requires the use of high-efficiency sensors and advanced digital signal processing to eliminate atmospheric electrical noise and identify the partial-discharge signals that, in some cases, are more than 100 times smaller than the background atmospheric electrical noise.

shielded steel-walled room in the field to test installed cable systems, the only way to achieve a factory-comparable result in the field is to use a factory-grade technology. This requires the use of high-efficiency sensors and advanced digital signal processing to eliminate atmospheric electrical noise and identify the partial-discharge signals that, in some cases, are more than 100 times smaller than the background atmospheric electrical noise.

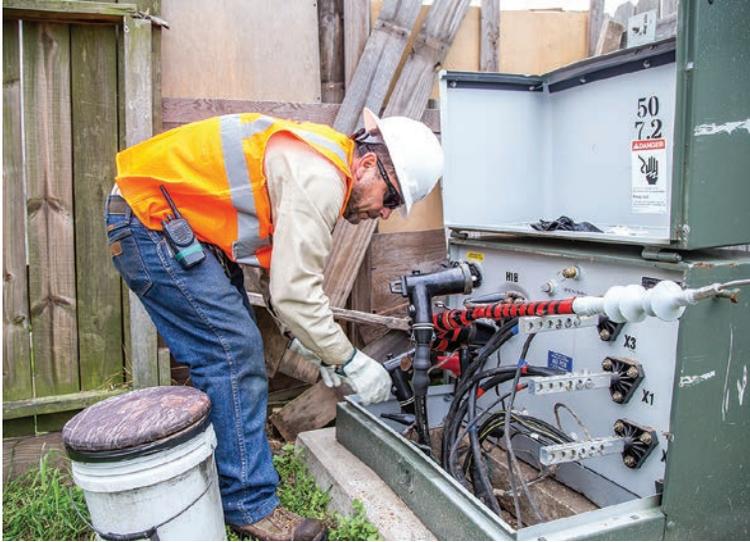
Line skill technicians prepare the infrastructure for assessment by isolating the spans and connecting the assessment equipment. A 50/60-Hz overvoltage is applied to the cable system for approximately 30 seconds while observing the response. The equipment has a verified ability to detect and locate 5-pC (five one-trillionths of a Coulomb) signal sources along the cable system.

and more than 140 million ft (43 million m) of installed cable systems using the factory-grade technology indicates the key to a reliable foot-by-foot profile is comparability to the factory quality-control standards. This requires specifically applying a 50/60-Hz overvoltage to the cable system for approximately 30 seconds (at peak voltage for less than five seconds) while observing a response with a verified ability to detect and locate 5-pC (five one-trillionths of a Coulomb) signal sources along the cable system.

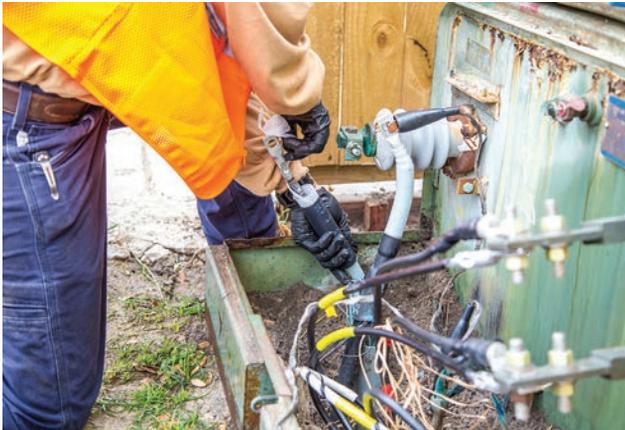
A line skill technician performs on-site mitigations to help improve reliability. Line skill support trucks are equipped with components such as a semiconductor replacement that enables crews to make a factory-grade cutback on the semiconductor while on-site for an assessment. When appropriate, these crews also implement surge protection tailored for 12-kV URD loops and open-tie transformers.

- Development of customized product solutions, of which among them is a semiconductor replacement that enables crews to make a factory-grade cutback on the semiconductor while on-site for assessment
- Efficient fleet practices, with mobile diagnostic units outfitted to take the laboratory to the field, and line skill support trucks equipped with components so mitigation can be done during assessment
- Implementing surge protection tailored for 12-kV URD loops and open-tie transformers.
